Harbor Tower Sealing of Stack 6 and 7 May 2023

Stack 6 & 7

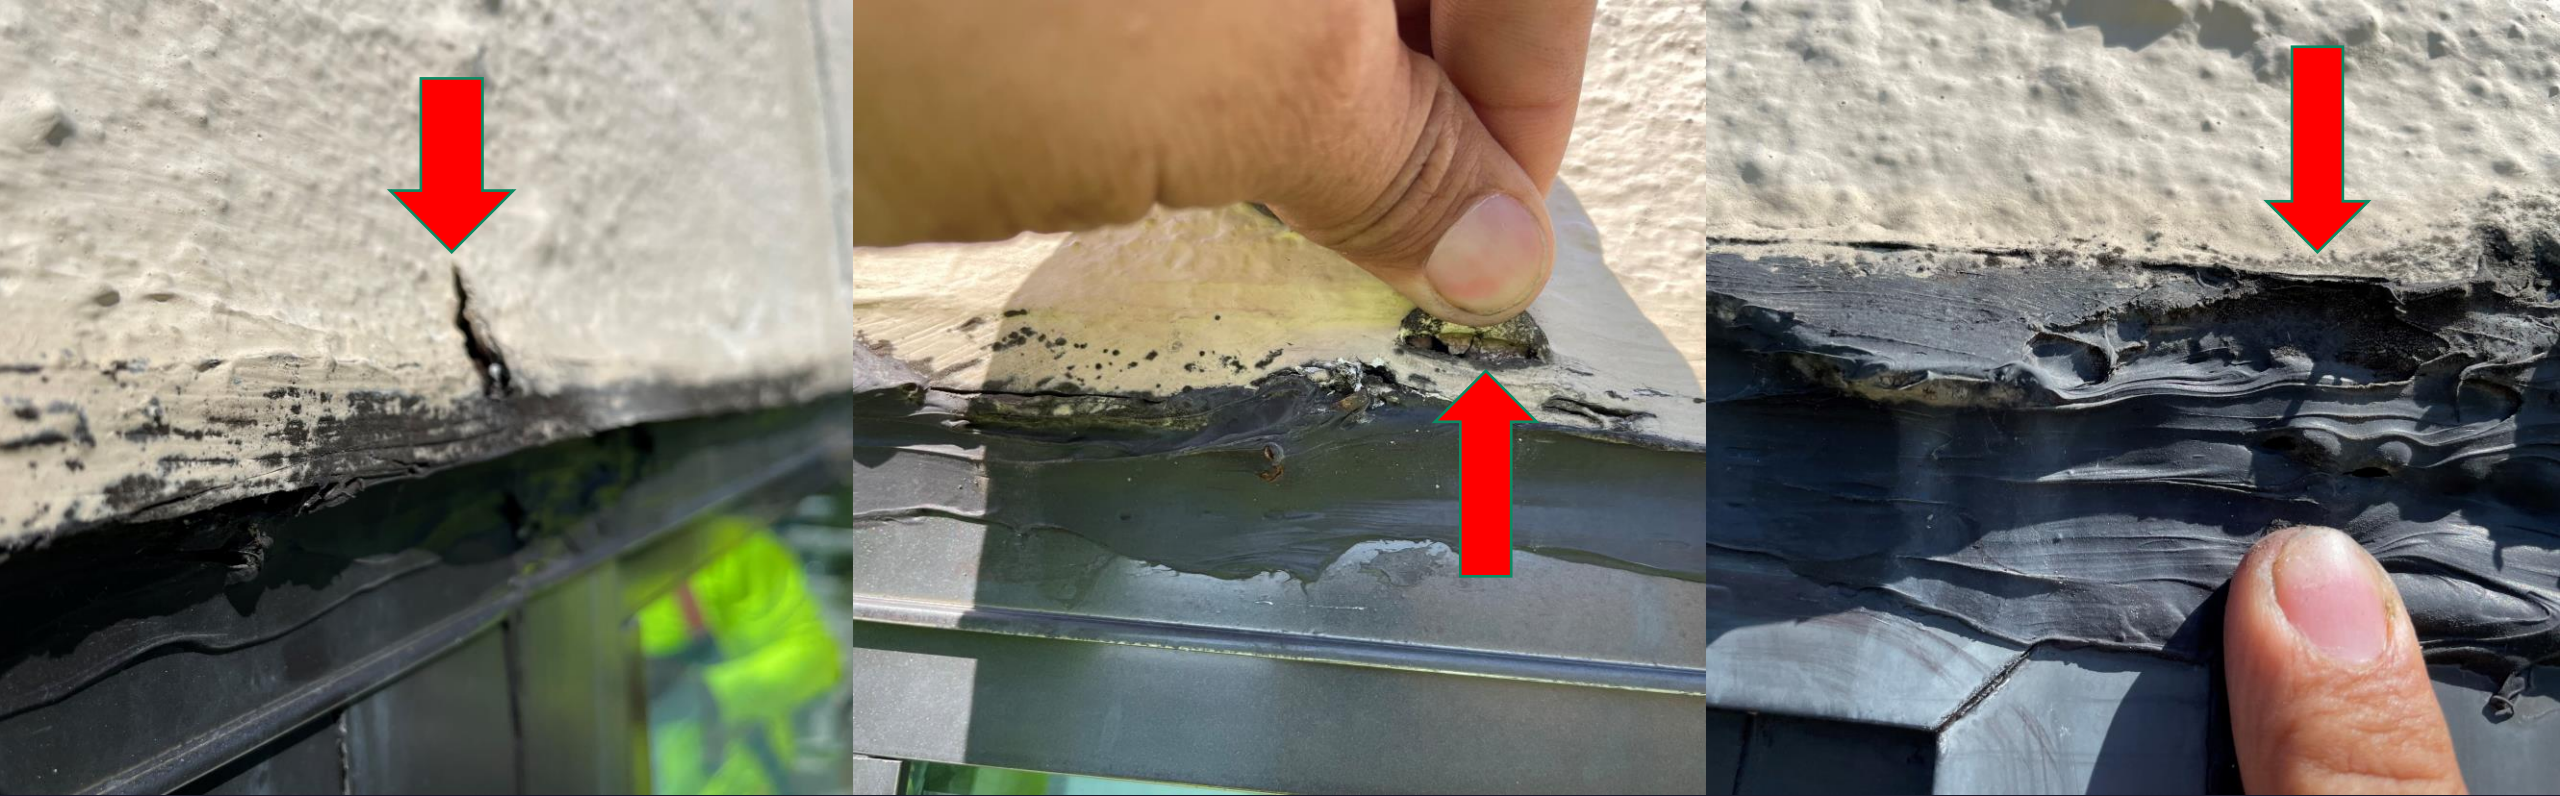
- Several areas where there were significant fractures with multiple holes in the stucco. This would be a significant source of water penetration.
- Several fissures in the stucco surrounding multiple window openings that would cause significant water intrusion from various weather events.
